Corrosion Analysis of Oil Drilling Pipes On Mobile RIG # 42.3 / N1500-E In Prabumulih

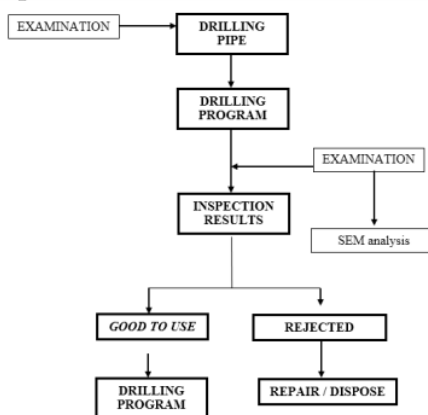
Figure 1. Research Flowchart

This thesis research was conducted in Prabumulih, South Sumatra for specimen selection according to predetermined variables and in the Bangka Belitung State Manufacturing Polytechnic laboratory for SEM (scanning electron microscope) testing. By using a drilling pipe material (G105) with a carbon composition of 0.38 - 0.43, manganese 0.75 - 1.00 max, phosphorus 0.035 max, sulfur 0.040 max, silicon 0.20 - 0.35, chromium 0.80 - 1.10, and molybdenum 0.15 - 0.25. In addition, it also uses several supporting tools, including ultrasonic thickness gauge, welding gauge, pH meter, and SEM (scanning electron microscopy) Park NX 10 for analysis. in Figure 1. describes the methodology used in research.

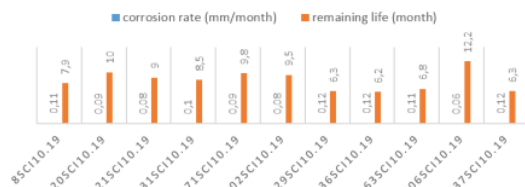
**Figure 2.** Corrosion Rate and Remaining Life

Based on the corrosion rate, the remaining life of the drilling pipe can be predicted to a minimum of 6.44mm. With the interim data, the minimum thickness of 7.2 mm is included in the calculation. By looking at the remaining life, it is close to the minimum standard limit to the minimum limit allowed by the DS-1 Volume 3 standard of 6.44mm (70% of the initial thickness).

Based on Figure 2, it can be seen that the difference in corrosion rates for the same type of pipe is due to differences in the rotation speed of the drilling, which when the temperature increases on the pipe surface causes Cl^- activity to increase, thereby reducing the composition of Fe_2O_3 by electrochemical reactions and damaging the structure of the oxide layer on the pipe [9]. The smallest remaining age is in the serial number 2375CI10.19, which is 6.3 months, while the largest remaining age is in the serial number 2065CI10.19, which is 12.2 months.

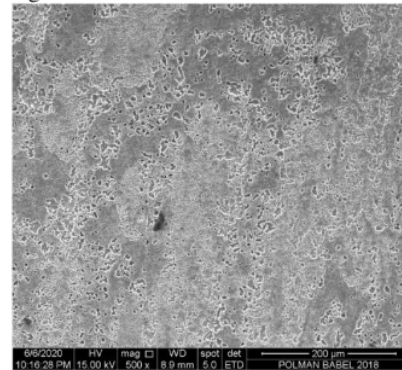
**Figure 3.** SEM Test Results 500X Magnification for Sample 129SCI10.19

SEM testing is used to see the form of corrosion that occurs in the specimen. SEM analysis was performed at 500X magnification.

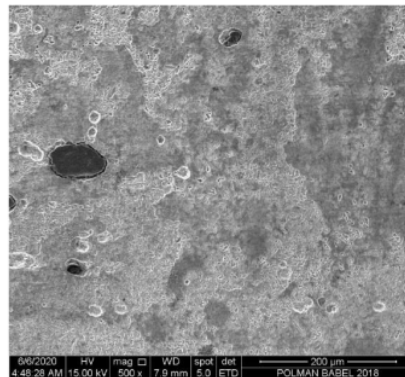
**Figure 4.** SEM Test Results 500X Magnification for Sample 136SCI10.19

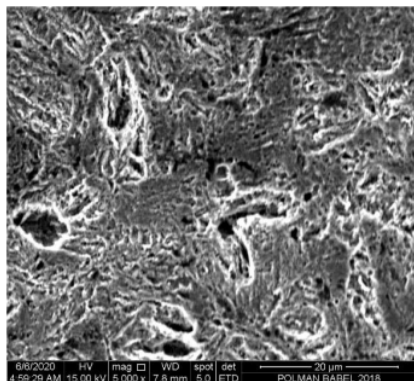
Figure 5. SEM Test Results 500X Magnification for Sample 136SCI10.19

In Figure 5, there is a windmanstatten structure, which is a surface exposed to two temperature differences, so that a layer is formed at a point which causes cooling to slow down causing overheating, then when exposed to lower temperatures it will cause rupture. This is in accordance with the way the drill pipe works with the fluid outside being hot, while the fluid inside the pipe tends to be cooler. The results of this study, the element of oxygen as a trigger for corrosion was found in the specimen.

Winmanstatten the structure above shows that the surface morphology of the carbon steel pipe specimen is not smooth, this is the initiation of damage to the surface due to the corrosion process. If this process is continued, the longer the corrosion products will be seen more clearly. When viewed from the results of the relatively small corrosion rate, to produce corrosion products the function of time also affects, the longer the observation time, the greater the corrosion rate value, besides that the corrosion products can be visually observed. This will be followed by changes in surface morphology, these morphological changes can be in the form of holes or cracks. [9]
