Corrosion Analysis of Oil Drilling Pipes On Mobile RIG # 42.3 / N1500-E In Prabumulih

Elfidiah¹, Kiagus Ahmad Roni^{2,*}, Agustriyono³

Abstract

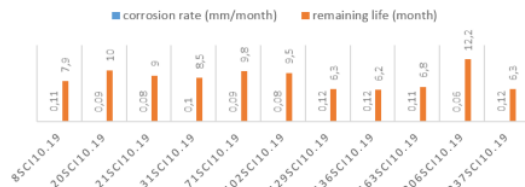
Figure 2. Corrosion Rate and Remaining Life

Based on Figure 2, it can be seen that the difference in corrosion rates for the same type of pipe is due to differences in the rotation speed of the drilling, which when the temperature increases on the pipe surface causes Cl⁻ activity to increase, thereby reducing the composition of Fe₂O₃ by electrochemical reactions and damaging the structure of the oxide layer on the pipe [9]. The smallest remaining age is in the serial number 237SCI10.19, which is 6.3 months, while the largest remaining age is in the serial number 206SCI10.19, which is 12.2 months.

Based on the corrosion rate, the remaining life of the drilling pipe can be predicted to a minimum of 6.44mm. With the interim data, the minimum thickness of 7.2 mm is included in the calculation. By looking at the remaining life, it is close to the minimum standard limit to the minimum limit allowed by the DS-1 Volume 3 standard of 6.44mm (70% of the initial thickness).

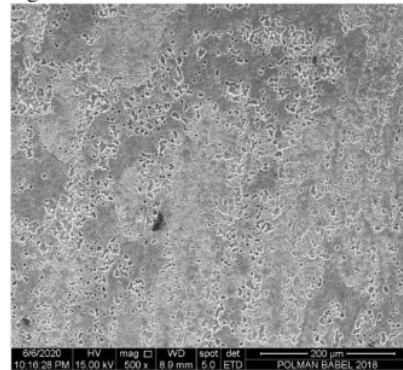
SEM testing is used to see the form of corrosion that occurs in the specimen. SEM analysis was performed at 500X magnification.

Figure 3. SEM Test Results 500X Magnification for Sample 129SCI10.19

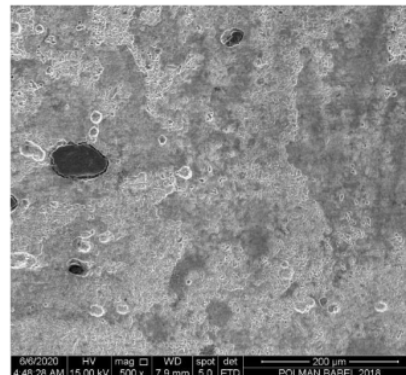
Figure 4. SEM Test Results 500X Magnification for Sample 136SCI10.19

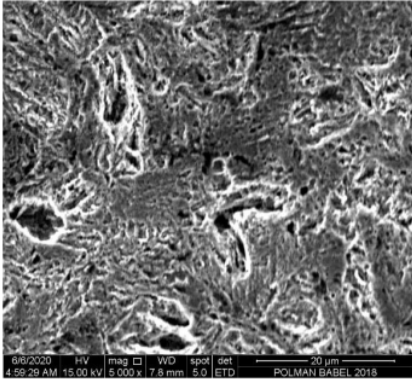
In Figure 5, there is a windmanstatten structure, which is a surface exposed to two temperature differences, so that a layer is formed at a point which causes cooling to slow down causing overheating, then when exposed to lower temperatures it will cause rupture. This is in accordance with the way the drill pipe works with the fluid outside being hot, while the fluid inside the pipe tends to be cooler. The results of this study, the element of oxygen as a trigger for corrosion was found in the specimen.

Figure 5. SEM Test Results 500X Magnification for Sample 136SCI10.19

Winmanstatten the structure above shows that the surface morphology of the carbon steel pipe specimen is not smooth, this is the initiation of damage to the surface due to the corrosion process. If this process is continued, the longer the corrosion products will be seen more clearly. When viewed from the results of the relatively small corrosion rate, to produce corrosion products the function of time also affects, the longer the observation time, the greater the corrosion rate value, besides that the corrosion products can be visually observed. This will be followed by changes in surface morphology, these morphological changes can be in the form of holes or cracks. [9]
